NASA CR-72334  
GEST-2101

IRRADIATION OF HIGH PURITY ALUMINA

T. L. Gregory

June, 1967

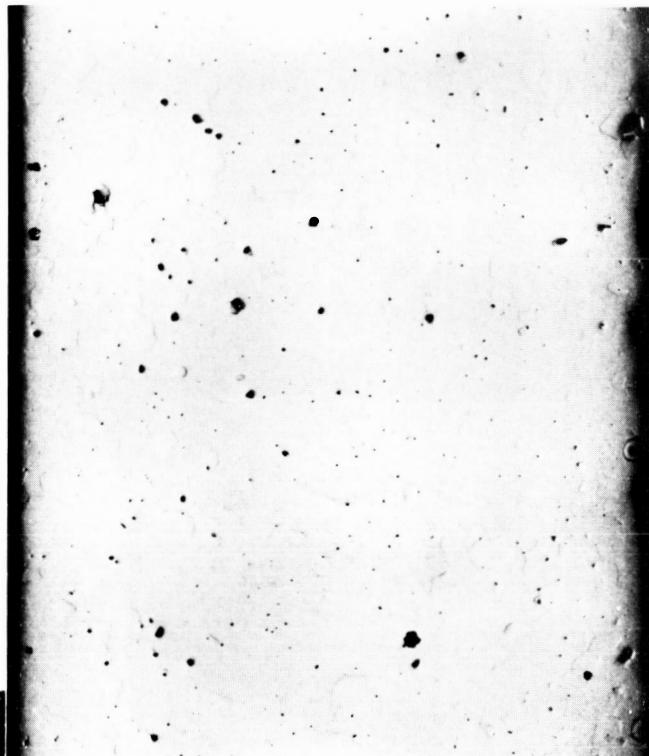
Figure 2. CYLINDRICAL SECTION OF THE SPECIMEN SHOWING TYPICAL POROSITY. AS-POLISHED, 100X

Only alpha phase alumina was observed metallographically. The specimen was slightly more porous than translucent Lucalox. The porosity in the cylindrical part of the specimen is illustrated in the ceramograph of Figure 2. The pores in the lip were somewhat larger in size; however, this porosity was not expected to significantly affect the electrical conductivity of the body when compared to 100% dense Lucalox.

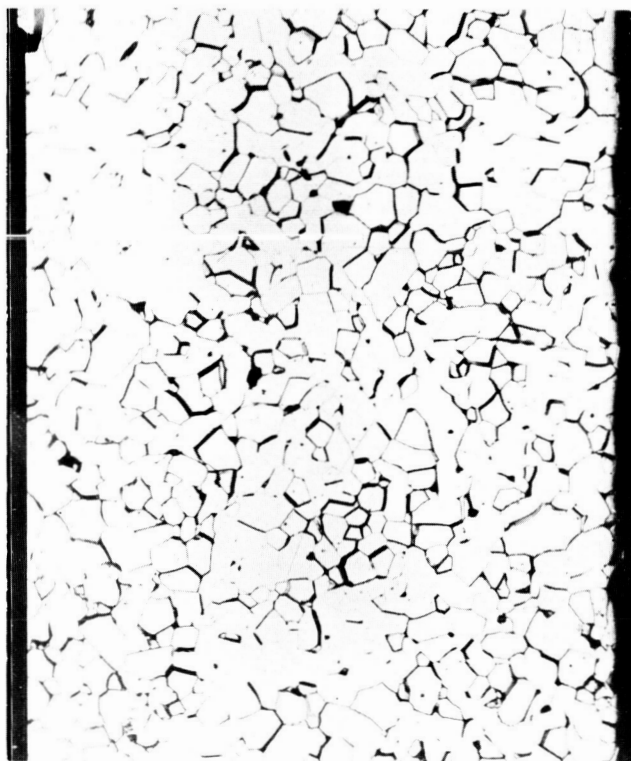
Figure 3. MICROSTRUCTURE OF THE CYLINDRICAL SECTION SHOWING GRAIN STRUCTURE. ETCHED, 150X

The Lucalox specimen was etched to reveal the grain boundaries and a typical microstructure is illustrated in Figure 3. The grains were relatively small and typical of the "high-strength" grade of Lucalox. The grain size is uniform throughout the entire body; the average grain diameter is about 0.0005 inch.
